**Resource Protection Area Assessment
of the
Rainbow River Ranch Parcel
(Preserve at Blue Run)
for
Rainbow River Conservation Inc.
December 23, 2013**

A Cursory Resource Protection Area (RPA) Assessment was conducted along the shoreline and aquatic areas adjacent to the property formerly known as the Rainbow River Ranch by Michael G. Czerwinski, Senior Environmental Scientist on behalf of Rainbow River Conservation Inc. on September 13, 2013 via boat access and snorkel survey. The purpose of the field investigation was to examine the environmental conditions and environmental resources present in the shoreline of the subject area, more specifically the presence or absence of beneficial submerged aquatic vegetation (SAV) more commonly referred to as grass beds; presence or use or potential use of the area by endangered or threatened fauna or flora, including the evidence of nesting wading birds; the condition of the shoreline, specifically the vegetative assemblage (wetland/ upland/ herbaceous/ Shrub/ forested / disturbed/) tree buffer or evidence of disturbance; and to examine the docks that had been constructed on site without proper permits. The inspection was limited to those a

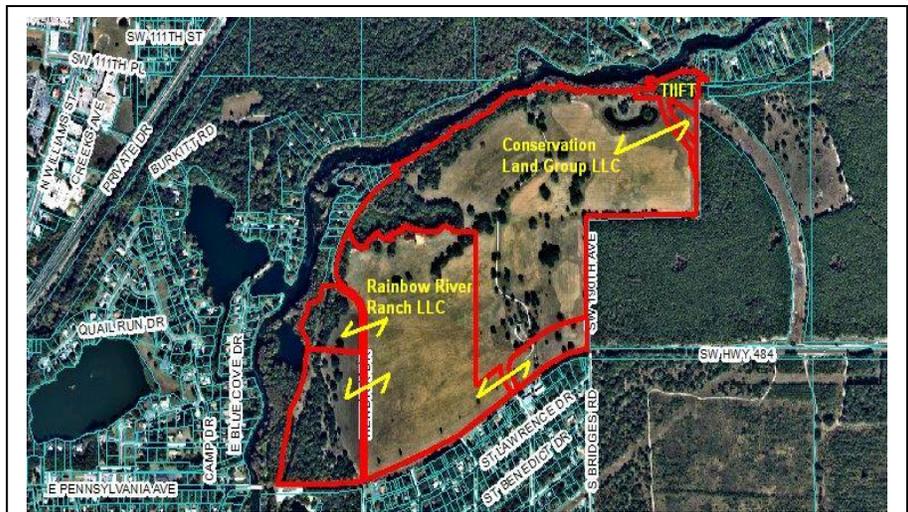
Figure 2. Rainbow River Ranch parcel(s)

The Rainbow River Ranch is located on the (south) eastern shore of the Rainbow River within the City of Dunnellon in Sections 25 & 36 Township 16 South, Range 18 East, and Section 30-16-19, Marion County, Florida. The site is bordered by County Road 484 to the south, the Rainbow River to the west and north, and S.W.190th Avenue and conservation lands as part of Rainbow Springs State Park to the east. The upland portion of the site

comprises approximately 247 acres (MOL). The subject upland land use / land cover is principally agricultural pasture and hayfield. A number of structures are present on site including the main ranch area close to CR 484 and a residence located near the river in the northern portion of the site.

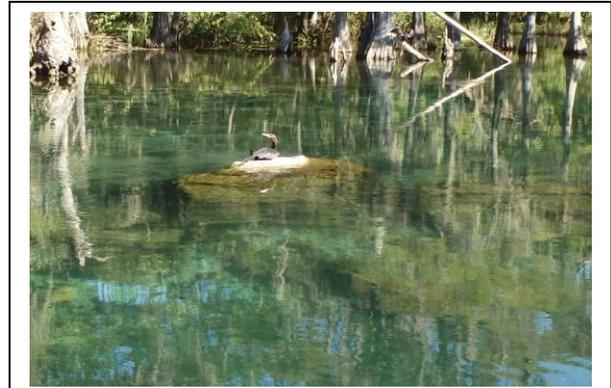
This habitat type is found at various places along the river, but within the study area only on the western side of the centerline of the river channel (tread). It consists of limestone or chert rocks that can vary from a flat plain to boulder and in some cases is interspersed with a vegetative type such as submerged grass beds (typically *S. kurziana*). These areas are important to the overall water scape (morphology) and flow characteristics of the river. For example, shallower bouldery areas can create areas of frictional rapid flow (riffles or rapids) that can be important for oxygenation of the water. Prominent rock out crops provide resting or basking areas for water birds (typically *Anhinga's*) or aquatic turtles.

Example of a rock outcrop near the subject site

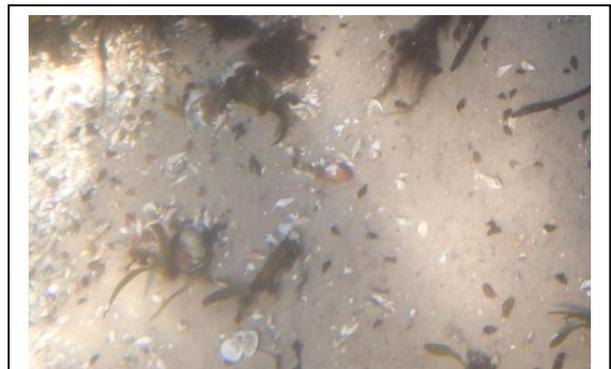
There are two basic types of unconsolidated substrate within the study area and the river in general. These include areas of fine sand, sometimes with a shell component where sand is the major component. The sand is typically light brown, yellow, tan or even white in color near spring boils. Many of the sandy areas near the headsprings appeared greenish and upon inspection were encrusted with a thin layer of microscopic algae or periphyton providing the green coloration. The second type of unconsolidated substrate is fine mud or organic detrital sediment created from the deposition and / or decay of plant material. The mud component is typically grey, brown or even black. Sandy areas are important for fish bedding, substrate for benthic invertebrates which contribute greatly to the aquatic food web and areas of potential colonization for beneficial SAV. Fresh water mussels (Florida Shiny Spike (*Elliptio* sp) and Florida Pondhorn (*Uniomorus carolinians*)), and snails and their abandoned shells are typically readily observable in sandy areas and were observed on site. The turban snail shells were most likely of the following species: (*Elimia*, *Melanoides*, *Tarebia* and/or *Tuberculata*). The Asian clam (*Corbicula fluminea*), an invasive species, has also been reported in the Rainbow River (GARI 2007). The presence of the opened or bodyless shells most likely indicates predation by wildlife.

Underwater photo of unconsolidated substrate consisting of fine sand with scattered dead freshwater snail and mussel shells

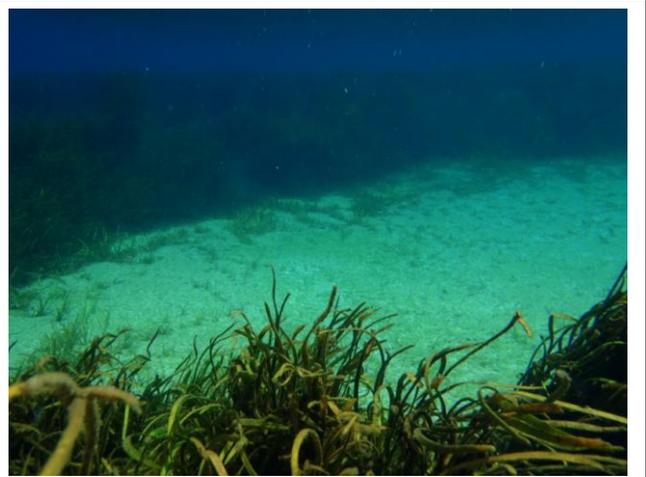
Submerged macrophytic vegetation consisting of spring tape (*Sagittaria kurziana*) and less commonly eelgrass (*Valisneria americana*), also referred to as grass beds are prevalent and arguably the most pristine resource of the Rainbow River. The best examples are near the headsprings and in the first few miles of the river where they persist as monocultures with minor amounts of *Hydrilla* or filamentous algae interspersed. Grass beds are present riparian to the subject site in variable cover from scattered to dense and some of the scattered or clumpy distributions are interspersed with filamentous algae and appear to be the most prone to being covered with periphyton or epiphytic algae.

Submerged grass beds interspersed with sandy non vegetated substrate areas near the headsprings.

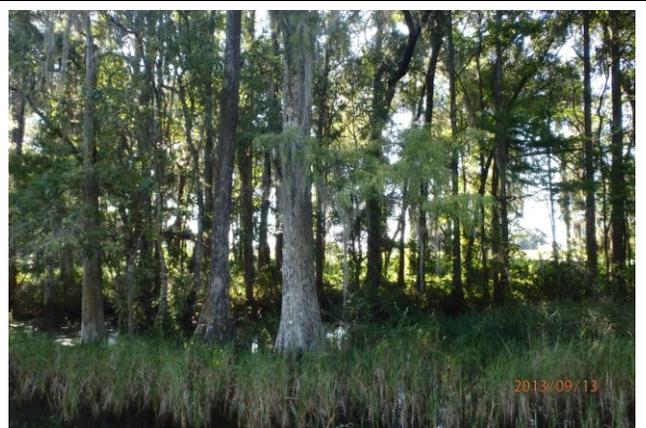
Emergent shoreline vegetation (knot grass) bordering the river at the subject site.

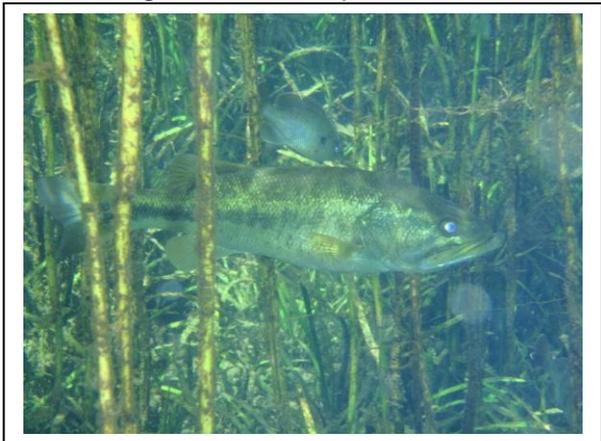
Underwater photo of knot weed stalks on Rainbow River providing structure and shelter to bass and sunfish

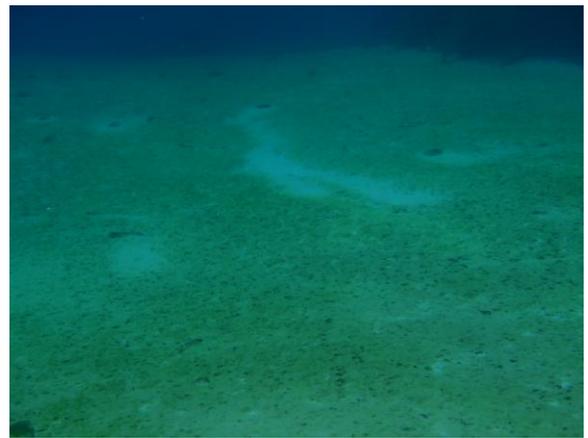
Spring vents are the physical fractures or openings in the rock or substrate within the river where water from the Floridian Aquifer emerges (discharges). The majority of spring vents are within the first few miles of the head waters. These can range in size from large openings large enough for a person to partially enter to a few inches in diameter. Spring vents can occur as a single opening or may be present in groupings of two or more. Much smaller isolated discharge areas can be found throughout the river within the substrate where the sand is typically observed in small circular “boils” on the bottom. No major spring vents were observed near the riparian areas of the subject property.

White sand areas where sand bubbles or appears to be boiling are small spring seeps or discharges in the sandy substrate

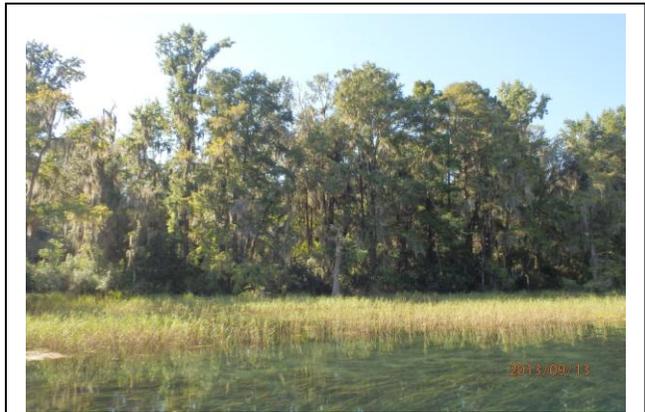
Photo of Rainbow River riverine swamp in background with emergent shoreline vegetation in mid ground and visible submerged grass beds in foreground.

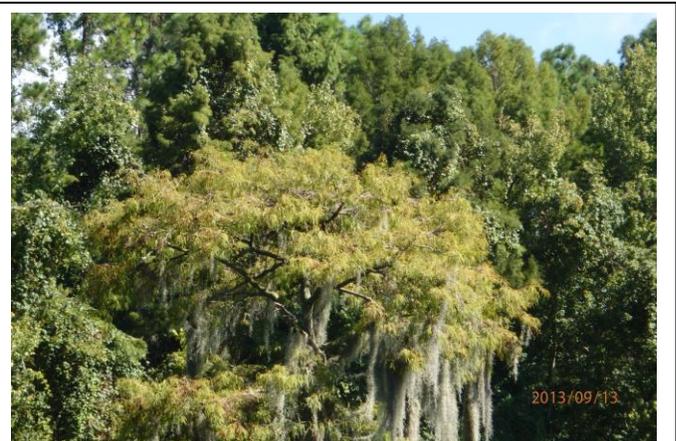
Dwarf Cypress tree on the west side of East Blue Cove that has supported nesting wading birds that have reportedly successfully fledged young and documented by residents.

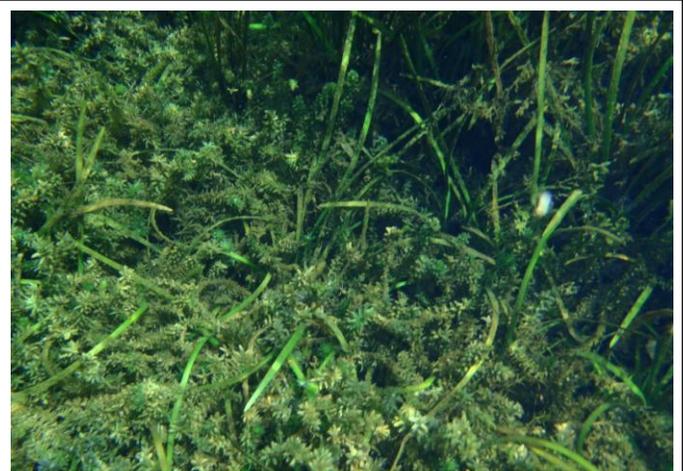
Submerged areas dominated by *Hydrilla verticillata* a nuisance aquatic plant. Hydrilla can occupy the entire water column from substrate to water surface where it can “top out” or lay recumbent creating a mat on the top of the water. Because of its rapid growth Hydrilla is a nuisance to navigation and boat traffic, but when kept in check it can provide beneficial fish habitat and oxygenate the water. *Hydrilla* as a monoculture was not observed in the shoreline areas near the subject site. Minor amounts of *hydrilla* were observed in the shoreline areas of the subject site mixed in with other submerged vegetation. It should be noted that the snorkel survey did not extend out into the waterbody past where the dock and a vessel would be moored.

Underwater photo example taken just south of the Rainbow Springs State Park showing short hydrilla dominating with minor amounts of spring tape.

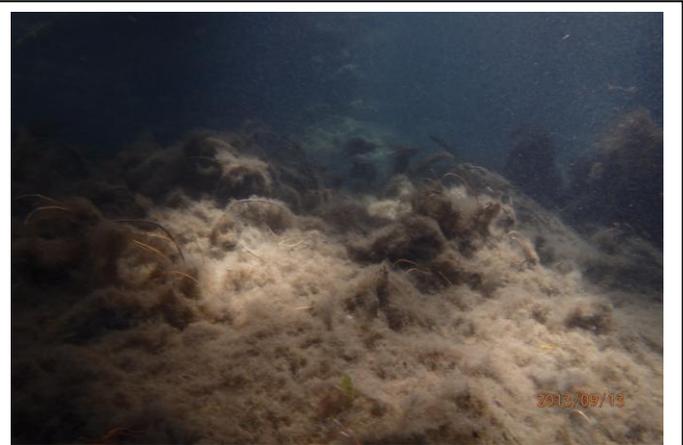
Filamentous algae, principally *Lyngbya* (sometimes classified as a cyanobacteria) is a hair like alga that can form large benthic (bottom) and surface mats. It typically smothers and kills native submersed plants. It is suspected that nutrient enrichment of the waters, specifically nitrate is the principal causative factor in algal dominance. However, it should be noted that phosphorous is considered a limiting nutrient in the growth of algal mats, i.e. small additions of phosphorous can cause rapid growth. The subject site was historically associated with phosphate mining and therefore natural and

Underwater photo of a decaying benthic (bottom) algal mat, principally composed of *Lyngbya* near the shore of the Preserve of Blue Run. Live algae are bright green to dark green.

waste phosphate products in the soil, and subsequent runoff and soil leaching may contribute to the presence of *Lyngbya* benthic mats near the shoreline of the site.
